95-24

Ground-Penetrating Radar Investigation of the Proposed Dome- CARA Tunnel Route and Utilities at South Pole Station, Antarctica

Steven A. Arcone, Wayne Tobiasson
and Allan J. Delaney

December 1995

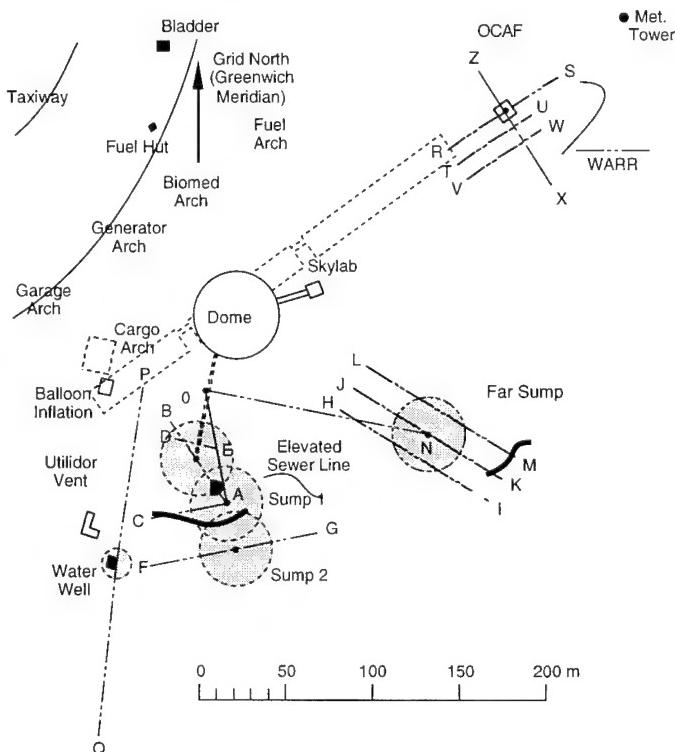
pressed into glacial ice) over various depths, and to locate or delineate subsurface facilities and utilities, or both. Figure 5 shows the general layout of South Pole Station and the surveys. The facilities discussed are the present water well, several sewage sumps produced over the years (indicated as sump 1, sump 2 and far sump), a utilidor and the buried Old Clean Air Facility (OCAF). Each survey line is lettered (e.g., FG) with the alphabetical order indicating the direction of the line. Several transects are indicated at each site, but not all are presented in this report as some did not traverse the features of interest. One Wide-Angle Reflection and Refraction (WARR) line (transmitter and receiver antenna offset constantly increased: on the diagram) was made near the OCAF to evaluate the refractive index of the surface snow. Dielectric information was gathered from all surveys. The weather during all profiles was clear with light winds and temperatures between -13 and -26°C, which necessitated placing the radar control unit within an insulated box.

Figure 5. Layout of facilities and radar survey lines (end points alphabetically marked) at South Pole Station, January 1993. Line marked WARR is a wide angle survey.

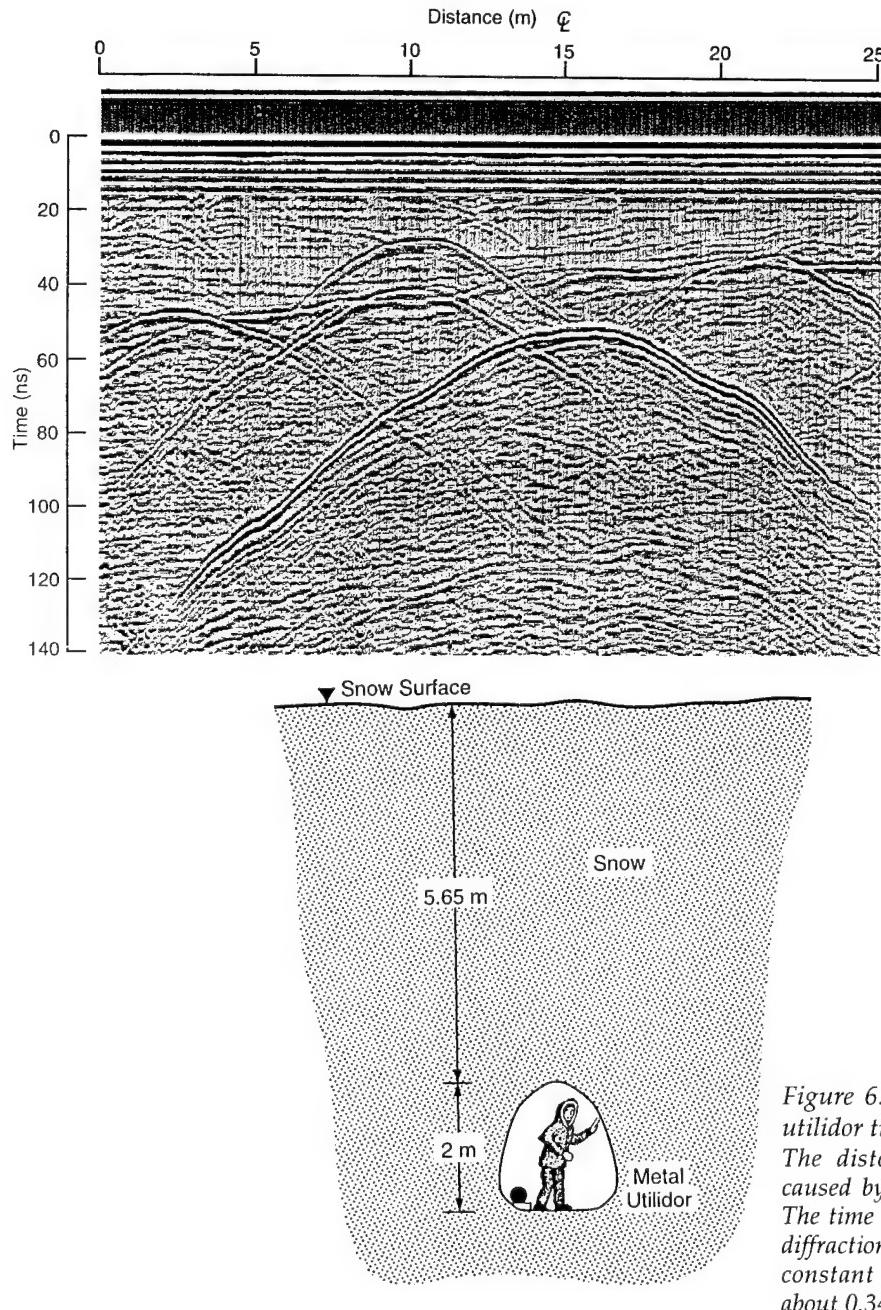
Figure 6. 400-MHz profile of the metal utilidor tunnel along line DE in Figure 5. The distortions in the diffractions are caused by uneven antenna towing speed. The time delay to the utilidor roof and the diffraction itself correspond to a dielectric constant of 1.57 and a snow density of about 0.34 g/cm^3 .

known. The distortions in the diffractions are caused by uneven towing speed. The more uniform left limb of the utilidor diffraction can be matched with a theoretical curve generated with a refractive index $n_m = 1.26$ ($\epsilon = 1.57$), which is close to the values (1.30, 1.69) corresponding to the velocity arrived at using the utilidor depth and time delay. These values correspond to snow density of $0.34\text{--}0.37 \text{ g/cm}^3$ (Cumming 1952) and are slightly less than other values obtained at the South Pole and discussed below.

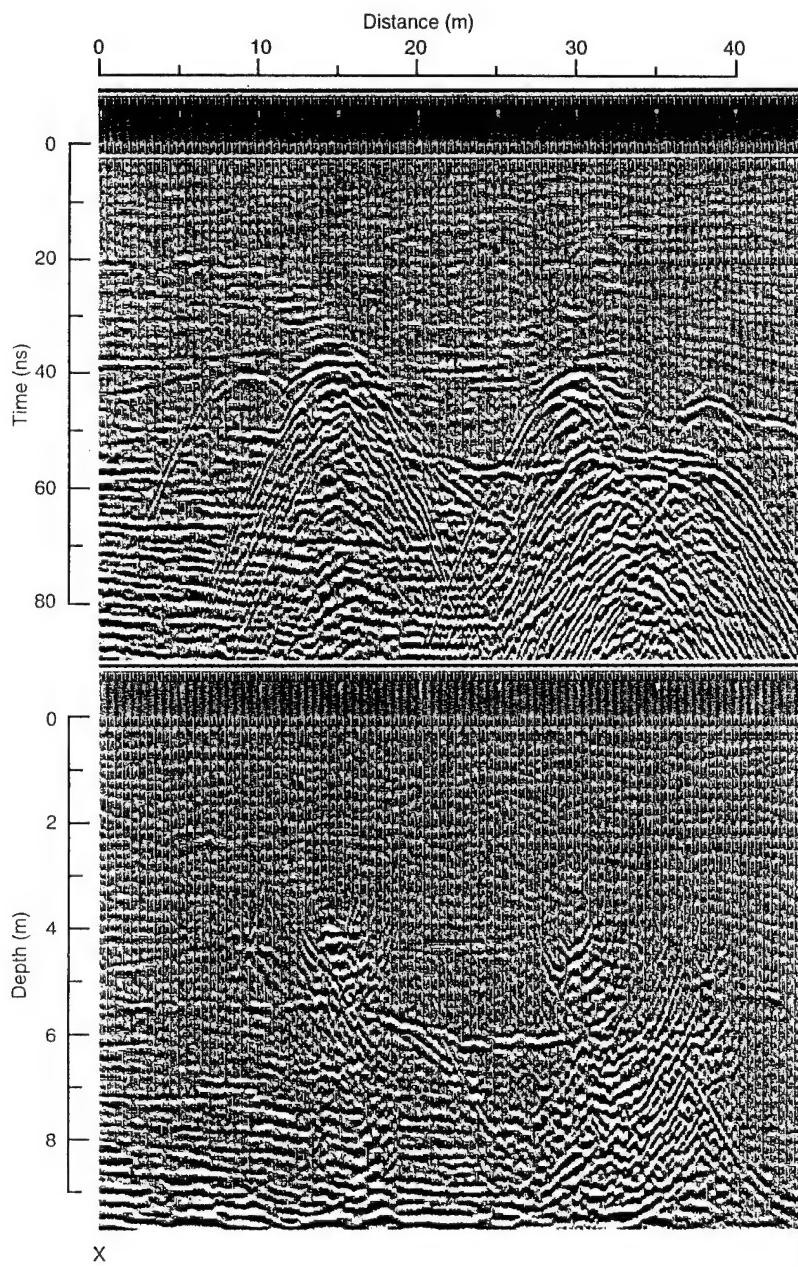
diagonal length = 9.8 m) and, 2) that there are many more diffractions originating at 60 ns towards point Z, suggest that there is more structure buried. The apexes of the prominent diffractions are at about 40 ns and the migrated data resolve these diffractions into two apparent columns. The strong diffraction originating at about 15 m collapses to a horizontal surface (i.e., coherent reflection) about 2 m wide at 4 m depth. The diffraction at 29 m distance also collapses to a coherent reflection at about 4 m depth, but it is not as linear. These diffractions could be responses to metal pipes placed to mark the location of the

Figure 7. 400-MHz profile (top) and its migration along line XZ that crosses the old clean air facility. Many of the diffractions in the top profile have collapsed into discrete events in the migrated section. The linear reflector provides convincing evidence that the building has been located.

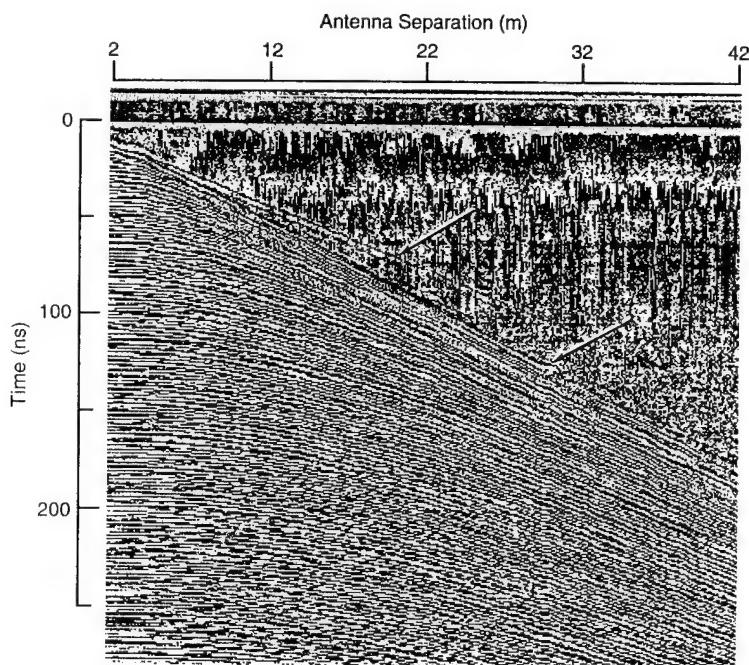
Figure 8. Wide angle reflection and refraction profile performed at about 400 MHz near the OCAF. Arrow 1 points to the directly coupled air wave, followed by the directly coupled ground wave (arrow 2). All other events become parallel with the ground wave. The slope of the ground wave corresponds to $n = 1.28$, equivalent to an approximate snow density of 0.33 g/cm^3 . Bright spots and noise bands are artifacts of the automatic gain control used to amplify the weak air wave.

The migration dielectric constant of 1.93 is an integrated value. The fact that ϵ increases with depth is demonstrated by the results of a WARR profile taken near the site (Fig. 8). The WARR used two Model 3102 units, one as a transmitter and the other as receiver; only the transmitter was moved. At the expense of noise amplification, automatic gain control was applied to this record to make visible the first event, the weak direct air wave coupling. The time-distance slope of the direct air wave coupling gives a velocity of 31.0 cm/ns , an error of about 3% over the actual value of 30 cm/ns . The ground wave slope gives a value of $n = 1.28$. This value of n corresponds to a near-surface density of about 0.35 g/cm^3 and, therefore, represents only the upper layers of snow. All subsequent subsurface reflections become parallel with the ground wave as they refract into the faster near-surface media; thus, refractions spend more time near the surface.

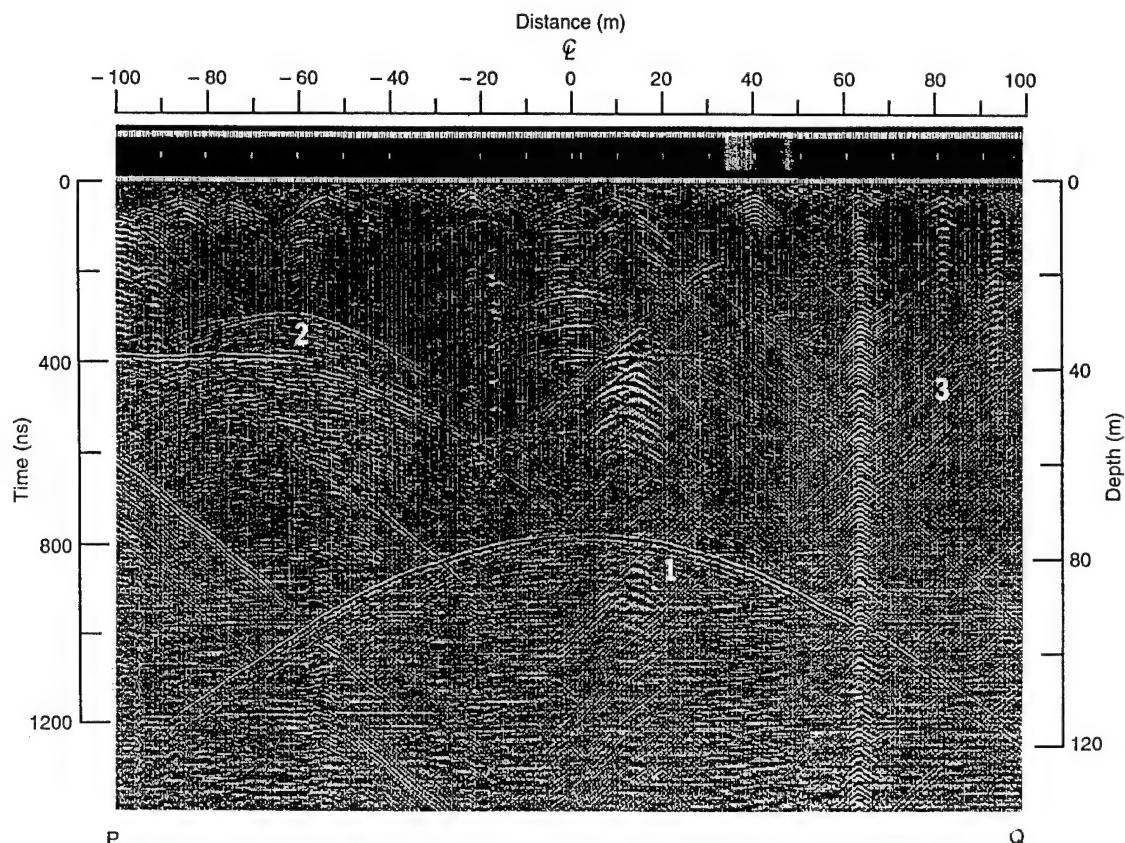
Figure 9. 100-MHz time section profile across the water well, the depth of which was 70.1 m. The asymptotic slopes of the hyperbolic diffraction from the well (1) give an $n_m = 1.59$; the slopes of the more shallow hyperbola (2) from an unknown object give $n_m = 1.46$; and the slopes of the resonant waves (3) generated by surface objects give $n_m = 1.36$.

A refractive index of 1.59 ($\epsilon = 2.53$) gives an almost perfect hyperbolic fit to this diffraction, and corresponds to an overburden average density of about 0.7 g/cm^3 . Alternatively, given the time delay and the measured depth to the water of 70.1 m, the effective refractive index for the firn overburden is determined to be 1.63 ($\epsilon = 2.66$). Although the estimated bulb diameter is 9 m, there is no evidence (e.g., two hyperbolae) of separate diffractions from each end of the bulb, as the temporal displacement of their asymptotes would be over 80 ns at the ends of the profile. Therefore, the diffraction itself, centered exactly at the center of the water well, is primarily a response to the complete well surface, but undoubtedly modified somewhat by the air bulb.

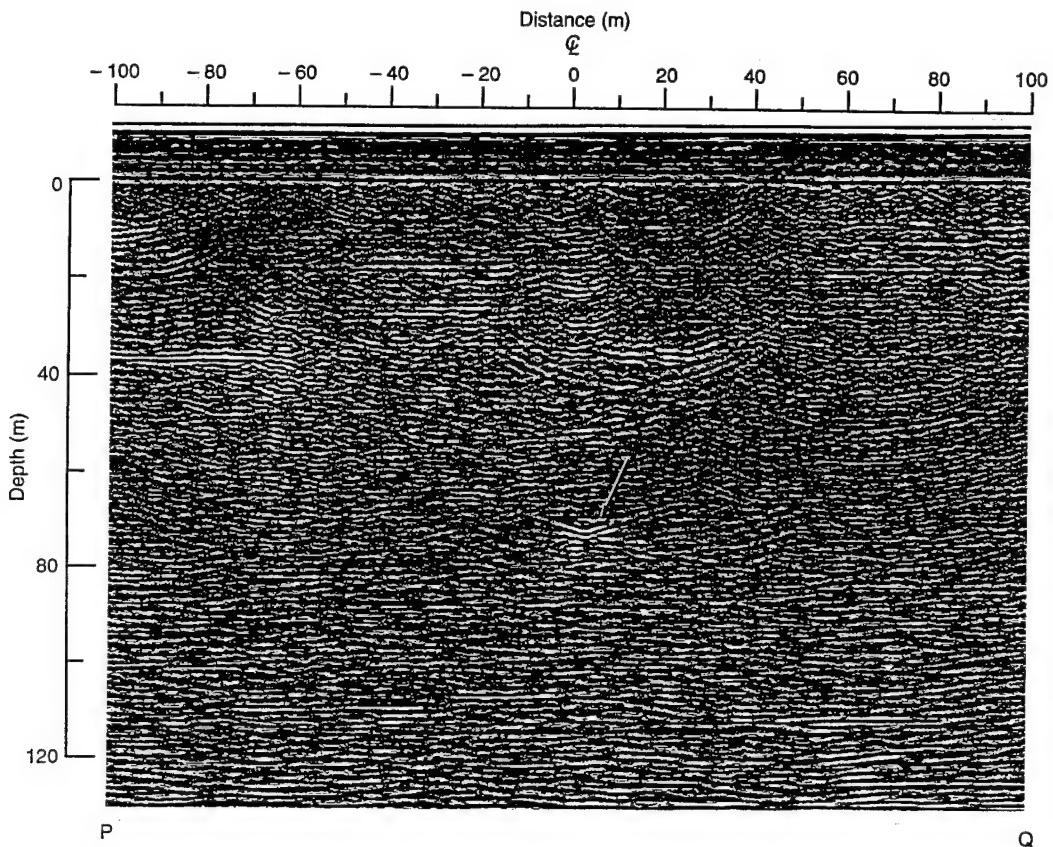
Figure 10. Migration of the water well profile seen in Figure 9. The central bright spot at 71-m depth (arrow) is the water well and its width may be ascribable to a migration algorithm artifact because the diffraction is almost a perfect hyperbola and should migrate to a point. More shallow events in the profile are improperly migrated because of changing velocity with depth.

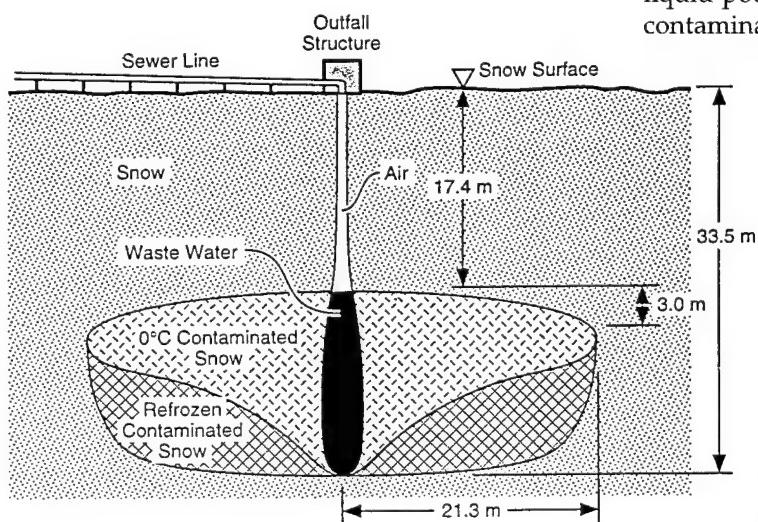
are marked in Figure 5. At the time of the survey, sump 1 was believed to look as depicted in Figure 11, which is based on prior CRREL and Metcalf and Eddy (M&E), Inc., measurements there and CRREL studies of similar sumps in Greenland. The surface of the central liquid pool was measured at

17.4 m below the snow surface during our surveys and the zone of sewage-contaminated 0°C snow was found the year before to extend radially about 21.3 m. At the extremities of the sump, the depth to the sewage-soaked material increases about by 3 m. This sump is in use and thus there is a central liquid pool and water in the upper portion of the contaminated snow.

Figure 11. Two-dimensional depiction of the disposition of sewage within sump 1 at location A in Figure 5.

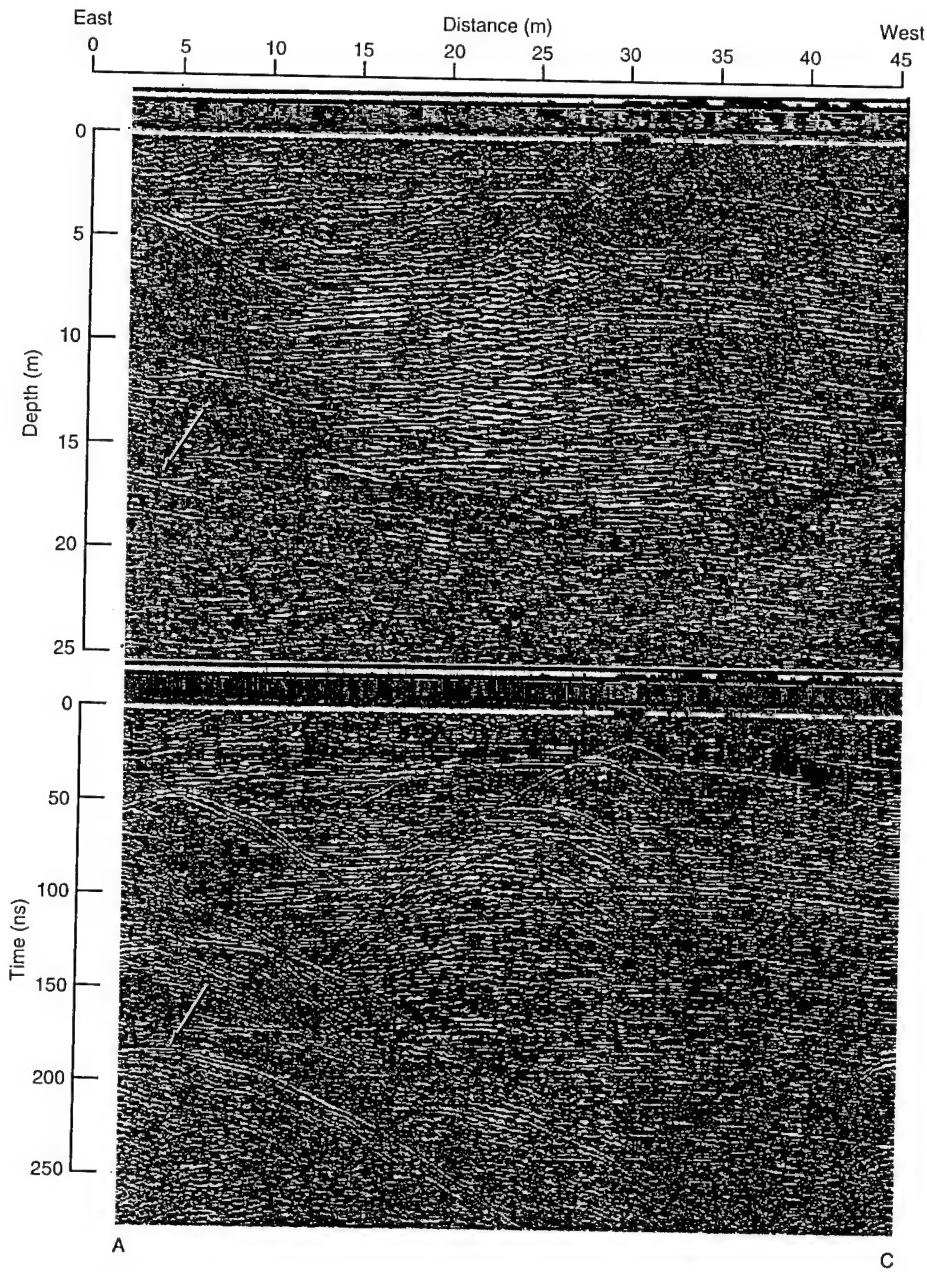
a. Line AC, which runs west from the sump 1 area. Arrows point to the response of the sump at a depth of about 17 m.

Figure 12. 400-MHz time-section profiles (bottom) and their migrations.

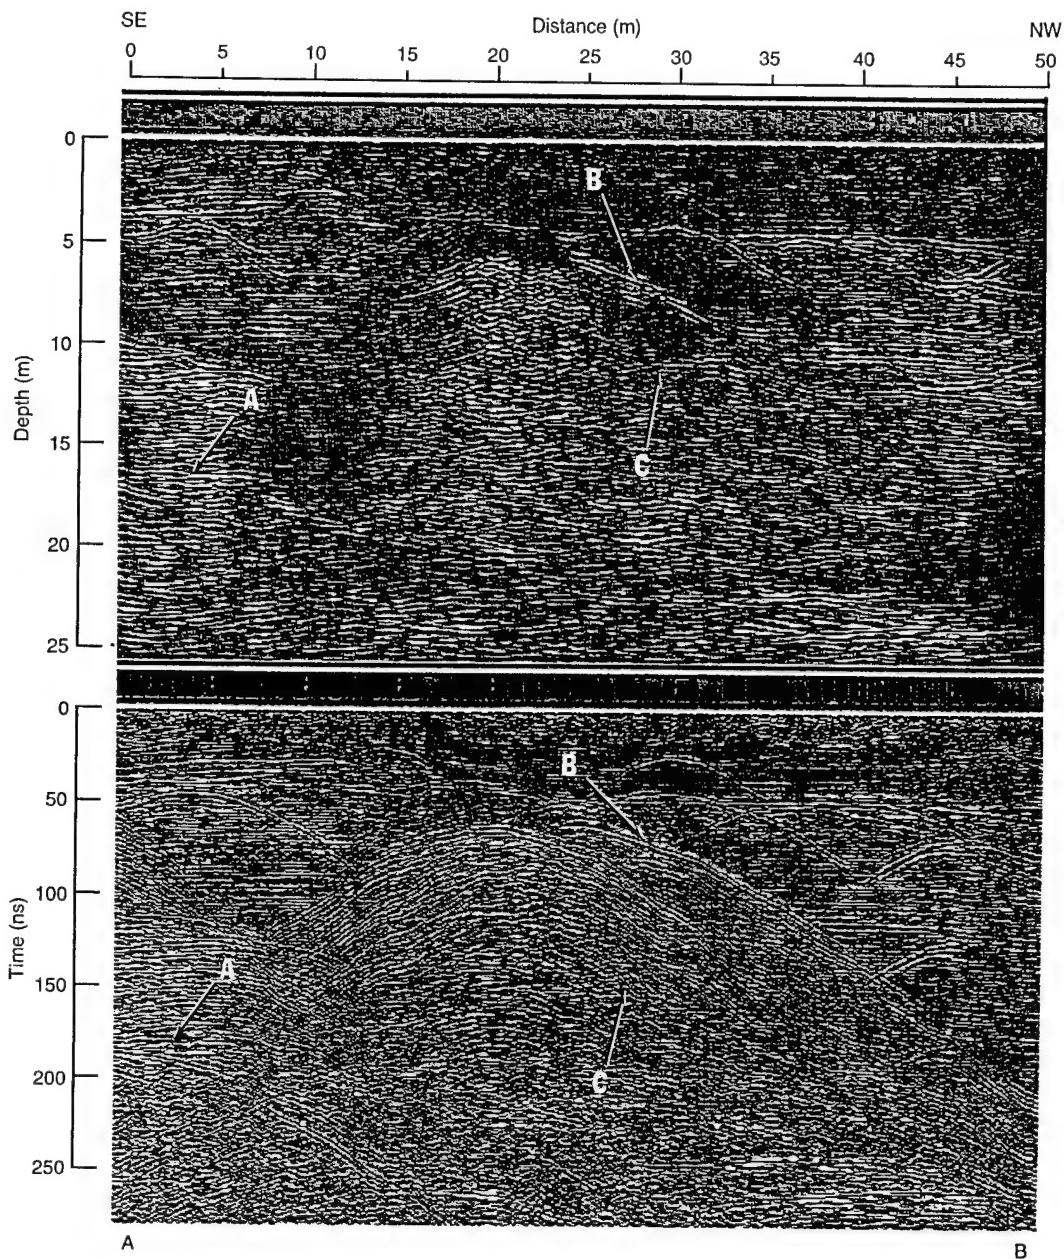
The time section profile in Figure 12b (bottom) along line AB starts at the center of sump 1 and passes near the utilidor vent at about 29 m and over the sewage sump centered about there. As shown in Figure 12a, the sump 1 response (arrow A) occurs at a depth of about 17 m and seems to extend only about 7 or 8 m northward. The diffraction response, which we believe is the utilidor roof

b. Line AB, which runs from the sump 1 to the utilidor vent in Figure 5. Arrow A points to the sump 1 response and arrow B to the probable response of the utilidor vent. The vent response migrates to a slope, which indicates increasing distance from the utilidor. The slope originates at 25 m and may indicate a positional error. The sump response at the vent is probably the diffractions indicated as C. The spread of sewage in both sums suggested by the migration is believed to be far too small.

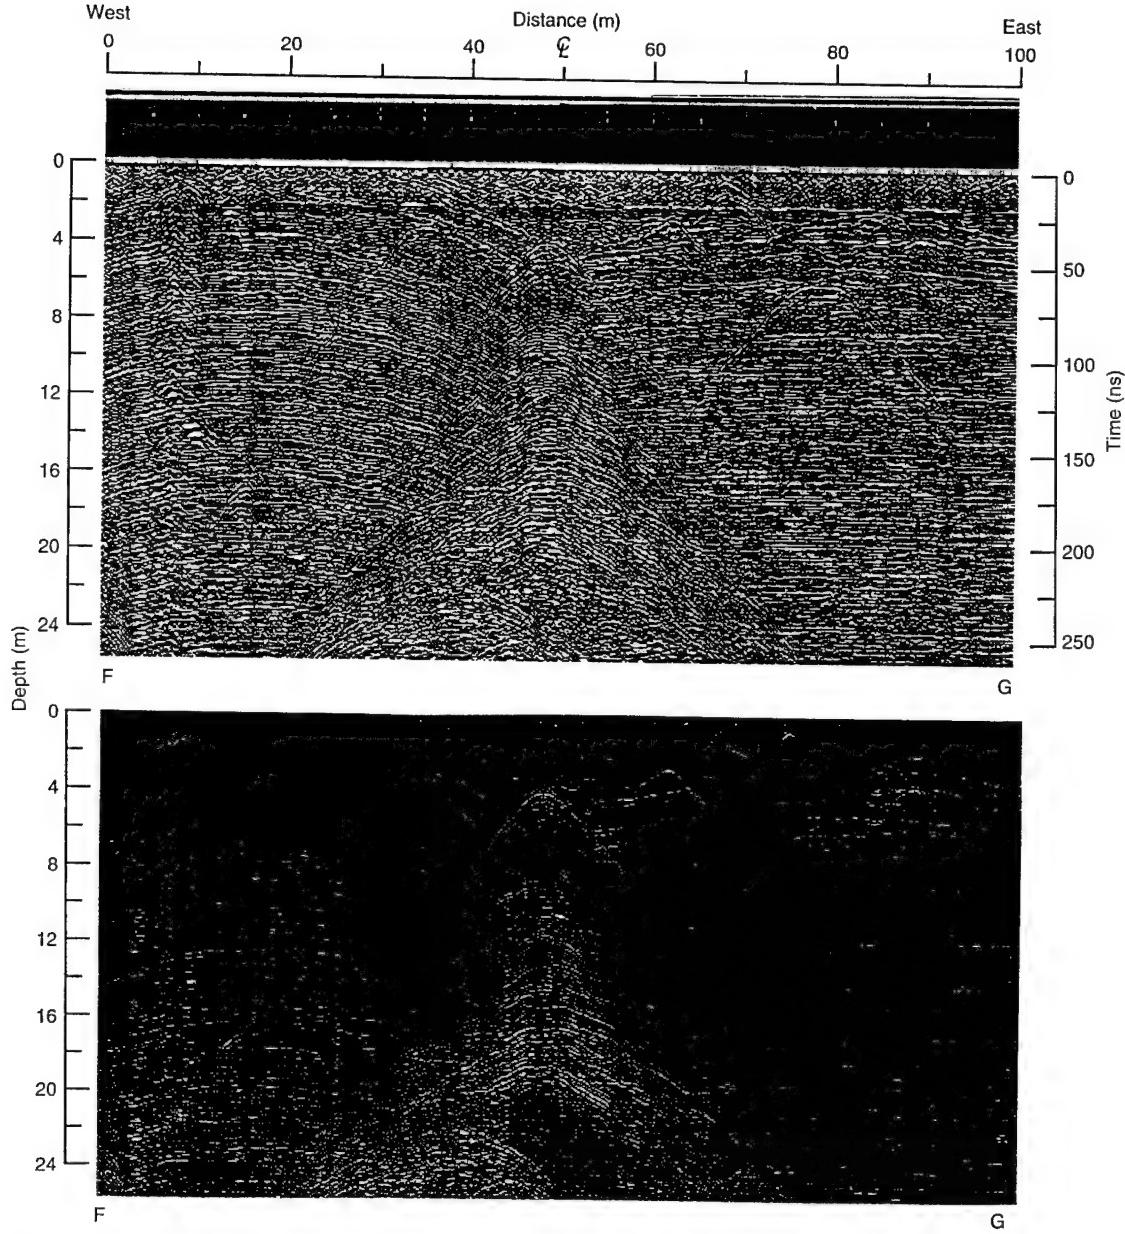
Figure 13. Two versions of the 400-MHz profile recorded at 300 ns across line FG over sump 2. The sump is centered at the 50-m distance. The bottom profile represents an estimate of the actual reflective strength throughout the sump and shows greater diffraction intensity below 12 m where frozen sewage begins. The later diffractions are strong enough to make their asymptotes visible. The top profile equalizes the intensity of all events and reveals the density horizons that subside toward the sump.

The top profile of Figure 13 equalizes the gain throughout the record so that all events are equally apparent, especially those from the density contrast interfaces, which appear to subside toward the sump. This subsidence is consistent with known increases in snow consolidation from warming in the vicinity of such sumps. Snow consolidation is also apparent from the refractive indices measured at sums 1 and 2; the values of 1.5 to 1.6 over the 16-m depth are higher than maximum values (1.4) found over similar depths along the tunnel survey.

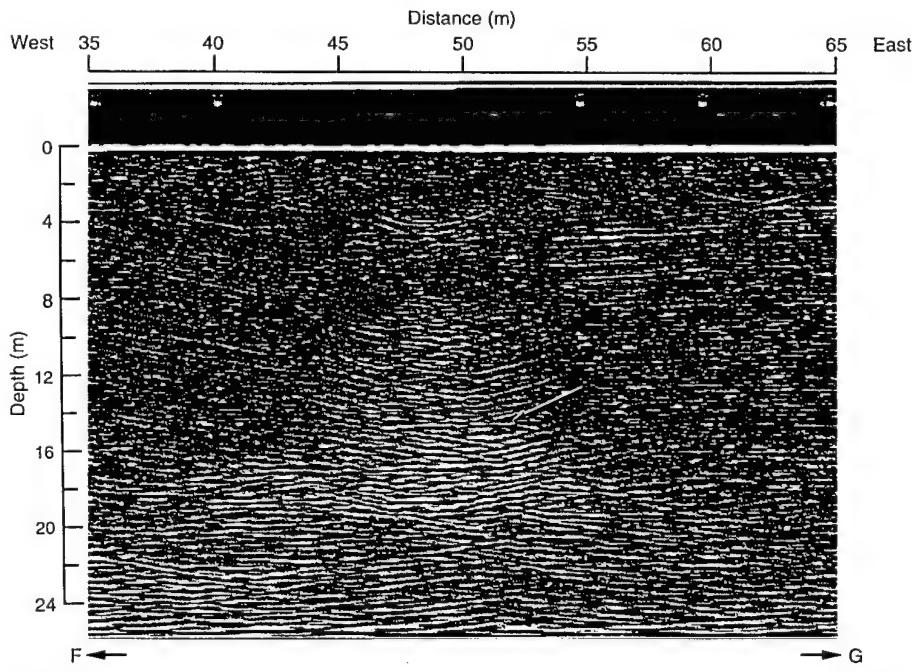
A migration of the central section of this profile is shown in Figure 14. Some of the peak signal strengths along the profile scans are amplified to bit saturation to allow us to view the deeper returns. The migration shows a coherent horizon at about 14 m depth and then reflections that spread asymmetrically to an approximate width (diameter) of 25 m at a depth of about 16 m. The sump 2 region seems to extend about 15 m to the west, but this sump is known to be refrozen and to extend radially about 20 m towards the water well. Therefore, we conclude that the contaminated firn beyond a 15 m radius did not produce detectable reflections.

Figure 14. Migration of the central section of the sump 2 profile using a migration velocity based on $n_m = 1.54$ (density 0.65). The section indicates that the sewage spreads to an estimated width (diameter) of 25 m, 15 m of which is towards the water well. Arrow points to a coherent reflection at about 14 m depth.

In summary, the contaminated areas of sumps 1, 2 and the sump below the utilidor vent seem well isolated from the water well. The radar indicates about an 8-m radius for the water well and a spread of about 15 m for the sump 2 contamination toward the well. This leaves more than 45 m separation between the well and the nearest contamination. Since the well bulb is below the contamination, the radar suggests that there is about 55 m separation between the nearest contamination and the water well itself. However, since probes indicate that the radii of the sewage sumps are about 21 m, not 15 m, it is likely that the actual separation is closer to 50 m.

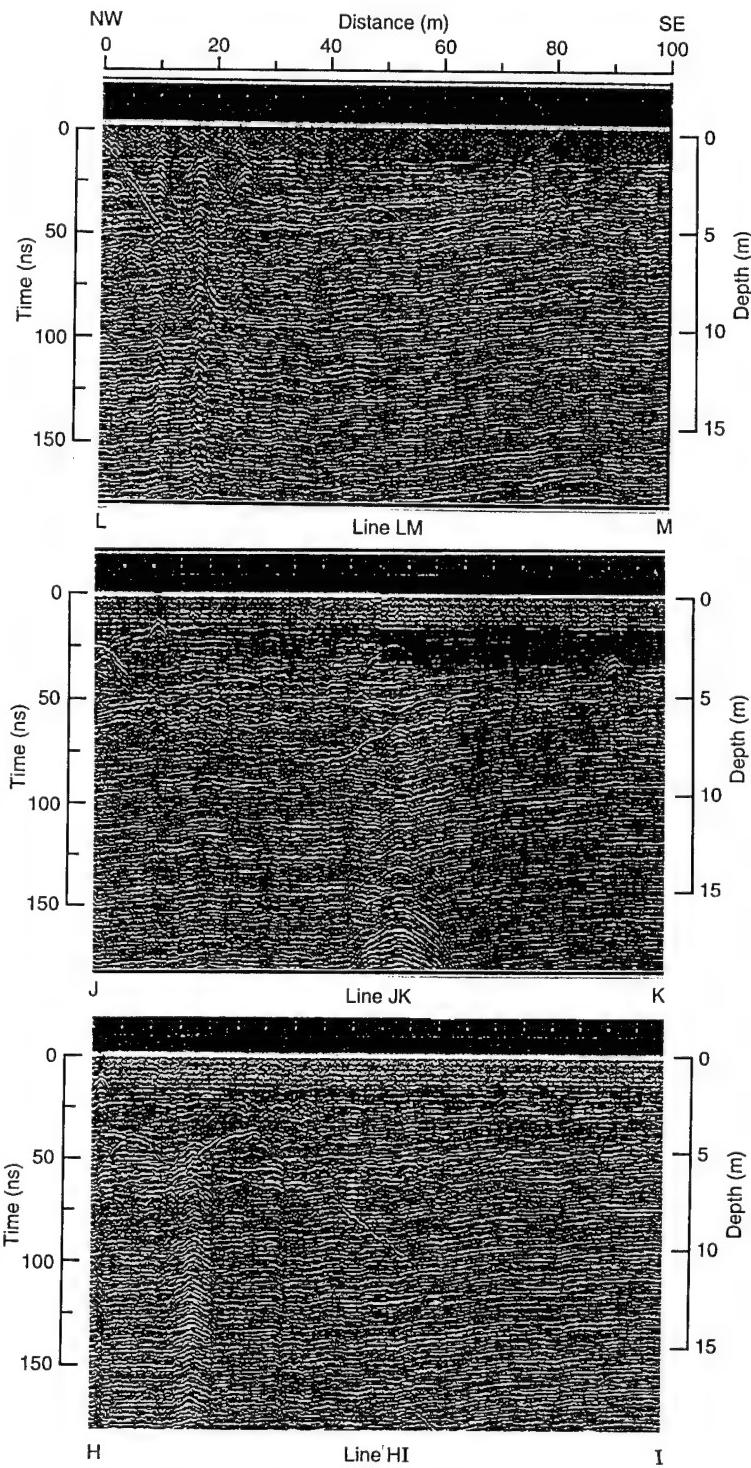
Figure 15. Three parallel 400-MHz profiles recorded at 200 ns at the far sump location (lines HI, JK, LM in Figure 5). Only line JK picked up diffractions at depth.

those seen around sump 2 in Figure 13 and is further evidence for firm subsidence around the sumps. None of the diffractions originating near 12 m depth are of unusual intensity, but at the 16- to 17-m depth, the diffractions become more in-

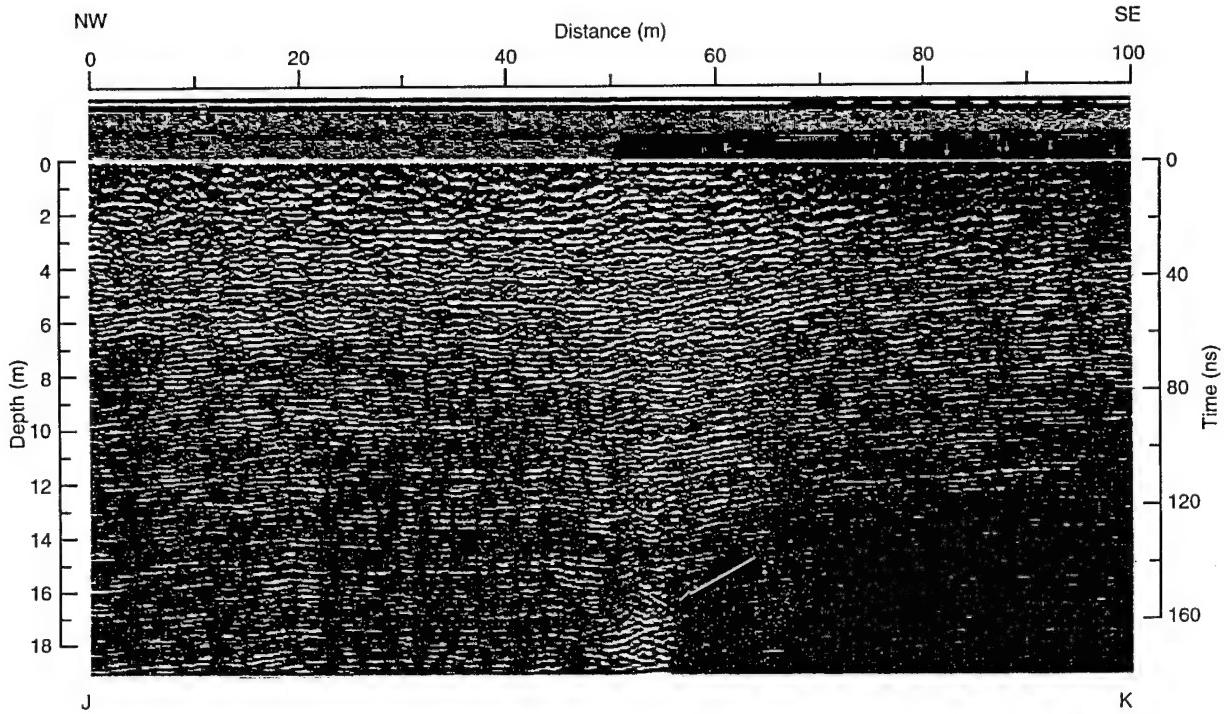
Figure 16. Migration of the profile along the centerline JK at the far sump. A concentration of sewage beginning at about 14 m depth is apparent, but there is no indication of the lateral spreading reported to exist.

tense. The migration of this record (Fig. 16) picks up these deeper targets, which probably represent layers of contaminated snow deeper in the sump. The radar records again suggest less lateral spread of contamination from the discharge point than the 21 m estimated by M&E.

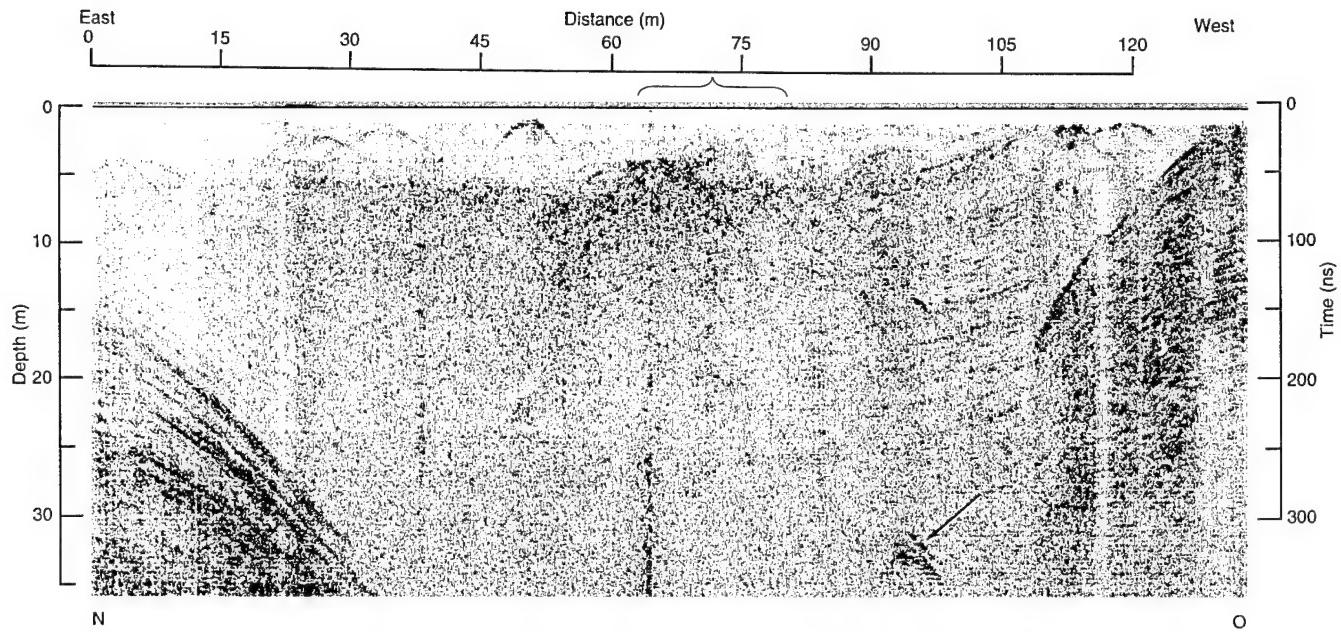
Several diffractions occur between the sump and utilidor that could be leaks along the sewer line. Although not easily visible in Figure 17, a cluster of weak diffractions between 64 and 80 m are candidates for shafts caused by leaks. The diffraction at 30 m depth about 93 m from N may be frozen sewage at the base of such a shaft.

Figure 17. 400-MHz time-section profile from the center of the far sump (point N) back toward the lift station. The diffractions beginning at about 15 m depth at point N are responses to the frozen sewage, but there is no indication of the lateral spreading previously reported because all these diffractions originate near point N. The bracket spans a cluster of weak diffractions whose depth indicates that they may be an old sewer leak, and the arrow points to a deep anomaly of unknown origin.

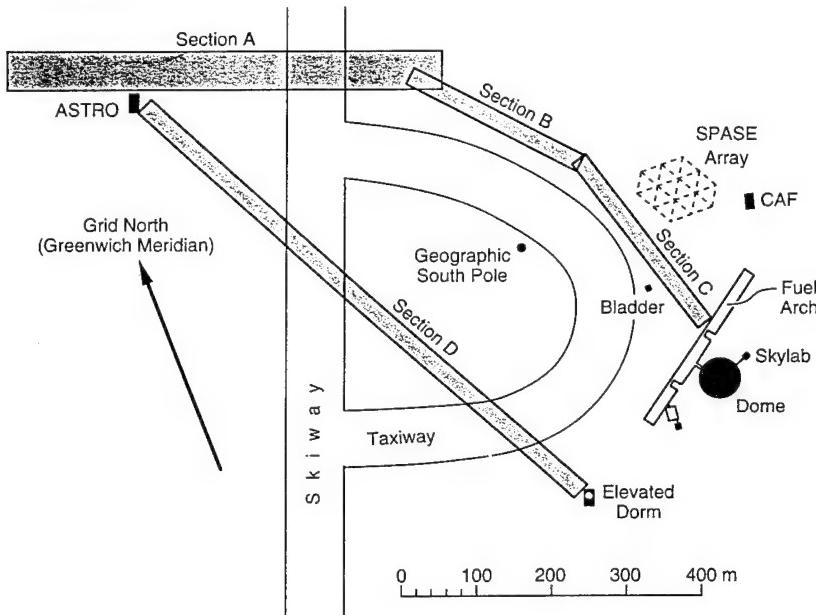
The two tunnel routes studied are shown in Figure 18. The upper route is divided into sections lettered A, B and C. So much buried debris was detected within the section A survey (originally 30 m wide) just west of the skiway that the width of that section was increased by 10 m to the south and 20 m to the north. Section D in Figure 18 is a narrow swath surveyed between the ASTRO facility and the elevated dormitory. All surveys consisted of parallel profiles, about 2.8 m apart, running the length of the sections. The profiles are alphabetically lettered and may be located later in Figures 21 and 22.

Figure 18. Proposed tunnel routes. Sections A, B and C run from the dome to the ASTRO and CARA (under construction) astronomical facilities. Section D is a 10-m wide section that extended 800 m from the ASTRO building to the elevated dormitory across the skiway.

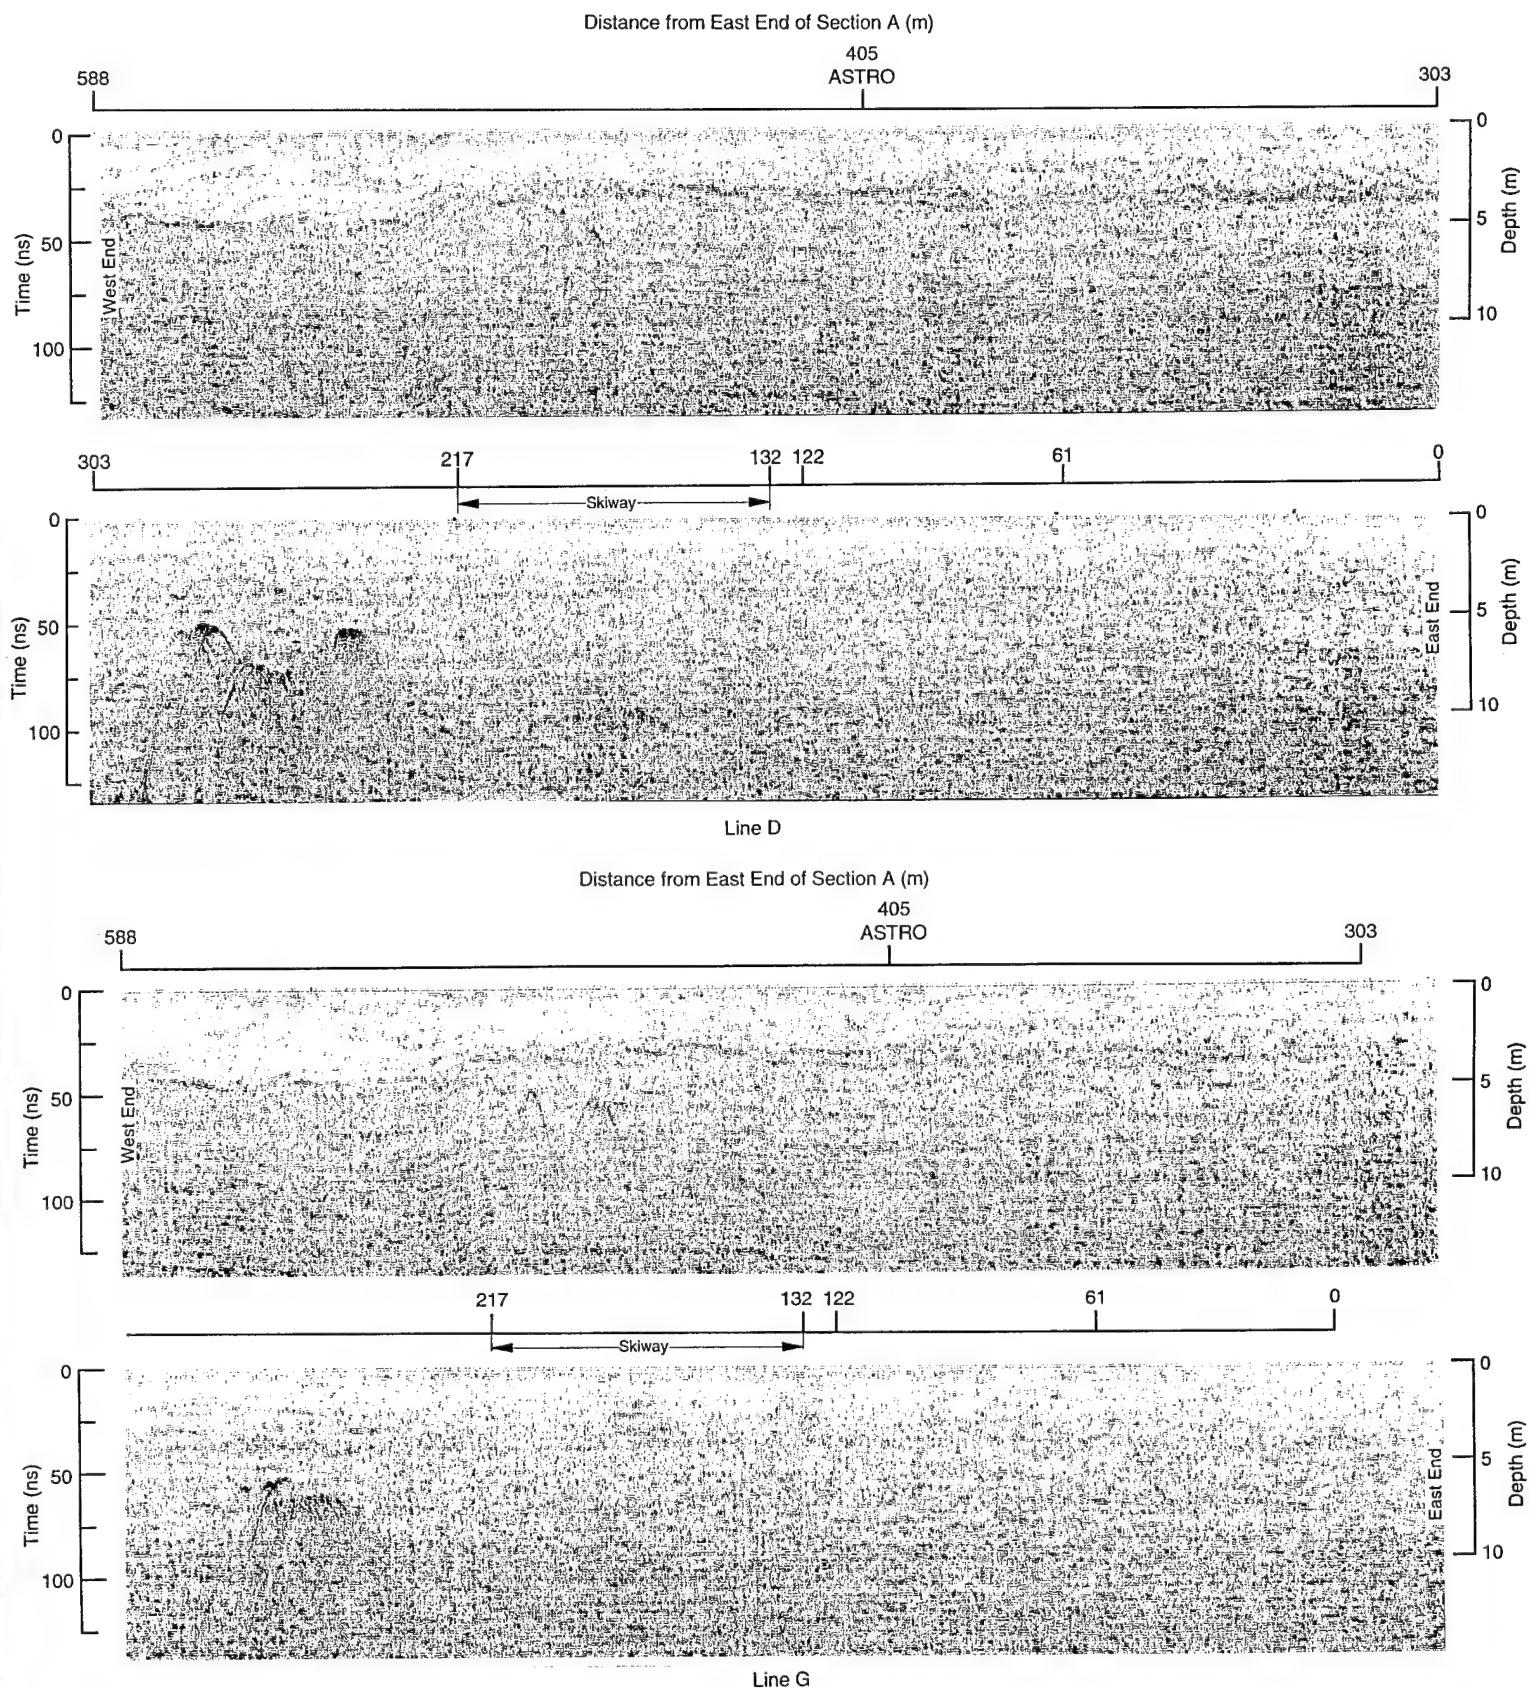
the stronger events. Both profiles show a heavy concentration of diffractions just west of the skiway. This concentration is characteristic of most profiles in this section and is the most formidable obstacle in the tunnel survey. Further to the west

Figure 19. Profiles of lines D and G along section A of the tunnel survey. The depth scale is based on $\epsilon = 1.93$. Many hyperbolic diffractions can be seen just west of the skiway. A horizon at 4- to 5-m depth is the work surface from previous operations at the first pole station established in 1957.

beyond the ASTRO complex several solitary diffractions may be seen. The location and depth of all these diffractions are plotted later in Figure 21. Also visible in Figure 19 is a horizon at about 3 to 4 m depth. This is believed to be dense snow caused by traffic between the old and new stations during the early 1970's when the new station was being constructed.
